# **Condition Assessment of Levees, U.S. Section of the International Boundary and Water Commission**

Report 5

Flood Simulation Study of Retamal Levee, Lower Rio Grande Valley, Texas, Using  
Seismic and Electrical Geophysical Models

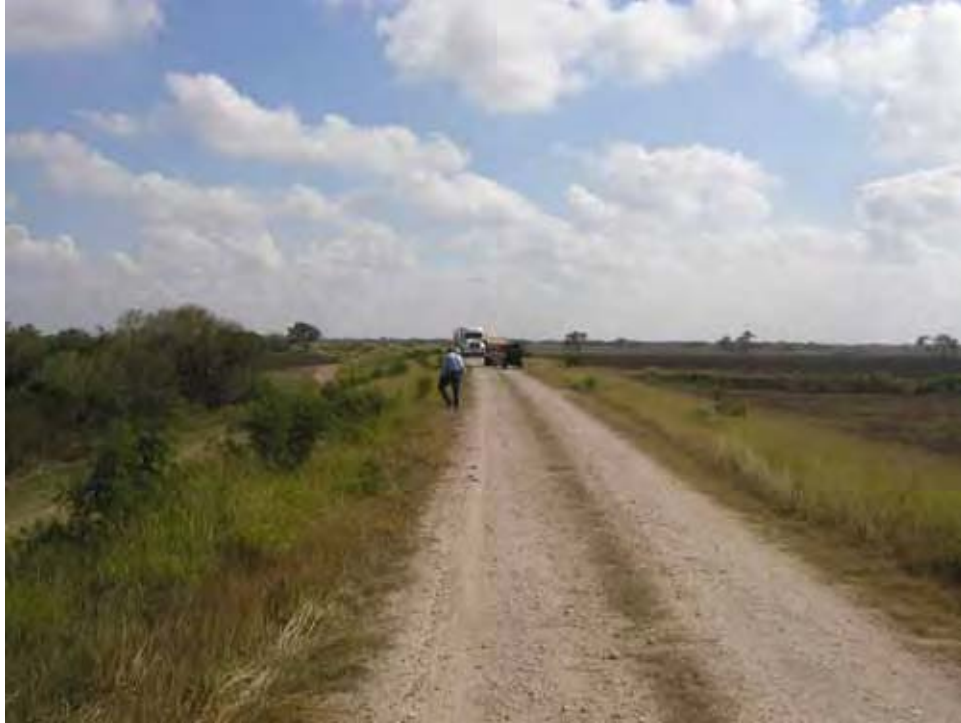
Figure 3. View of Retamal levee looking east toward test pond site (approximate location of semi-truck)

Retamal levee is approximately 4.3 m (14 ft) tall at the test pond site. Levee slopes are defined by the ratio of one vertical to three horizontal (1V:3H), pictured in Figure 3 and Figure 4. Retamal levee and dam were constructed in 1973 to 1974, after Hurricane Beulah struck the south Texas coast in September 1967. Retamal levee and dam were constructed to divert 40 percent of a design flood into the Mexican Floodway, and limit the discharge of a design flood to only 20 percent into the Rio Grande channel below the dam. Banker and

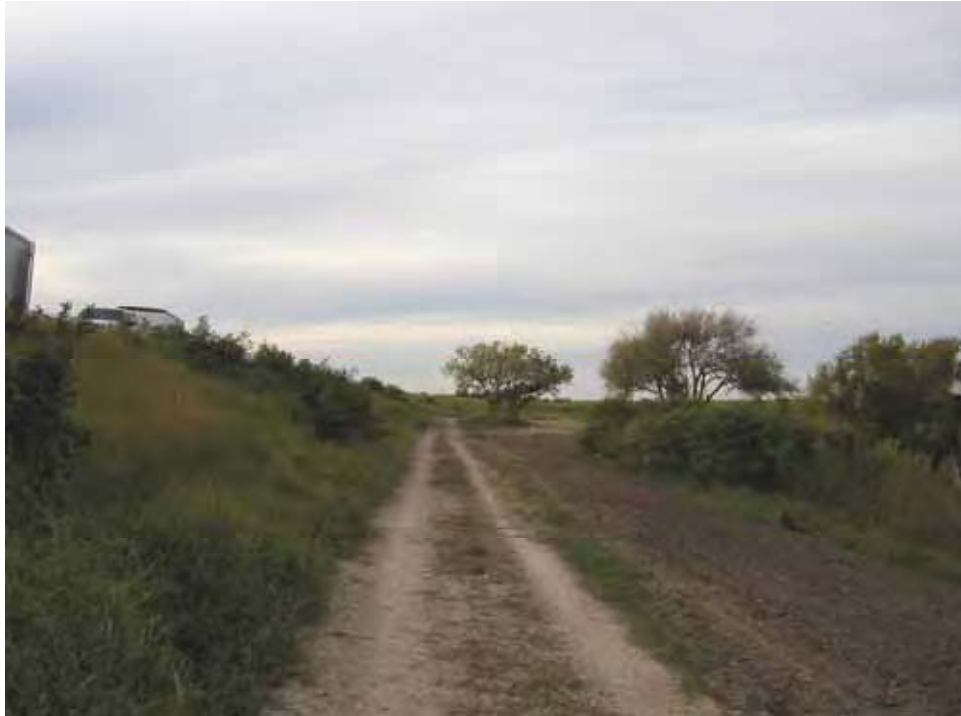
Figure 4. View looking west at landside toe of levee. Location corresponds to test pond site. Levee is approximately 4.3 m (14 ft) tall at this location

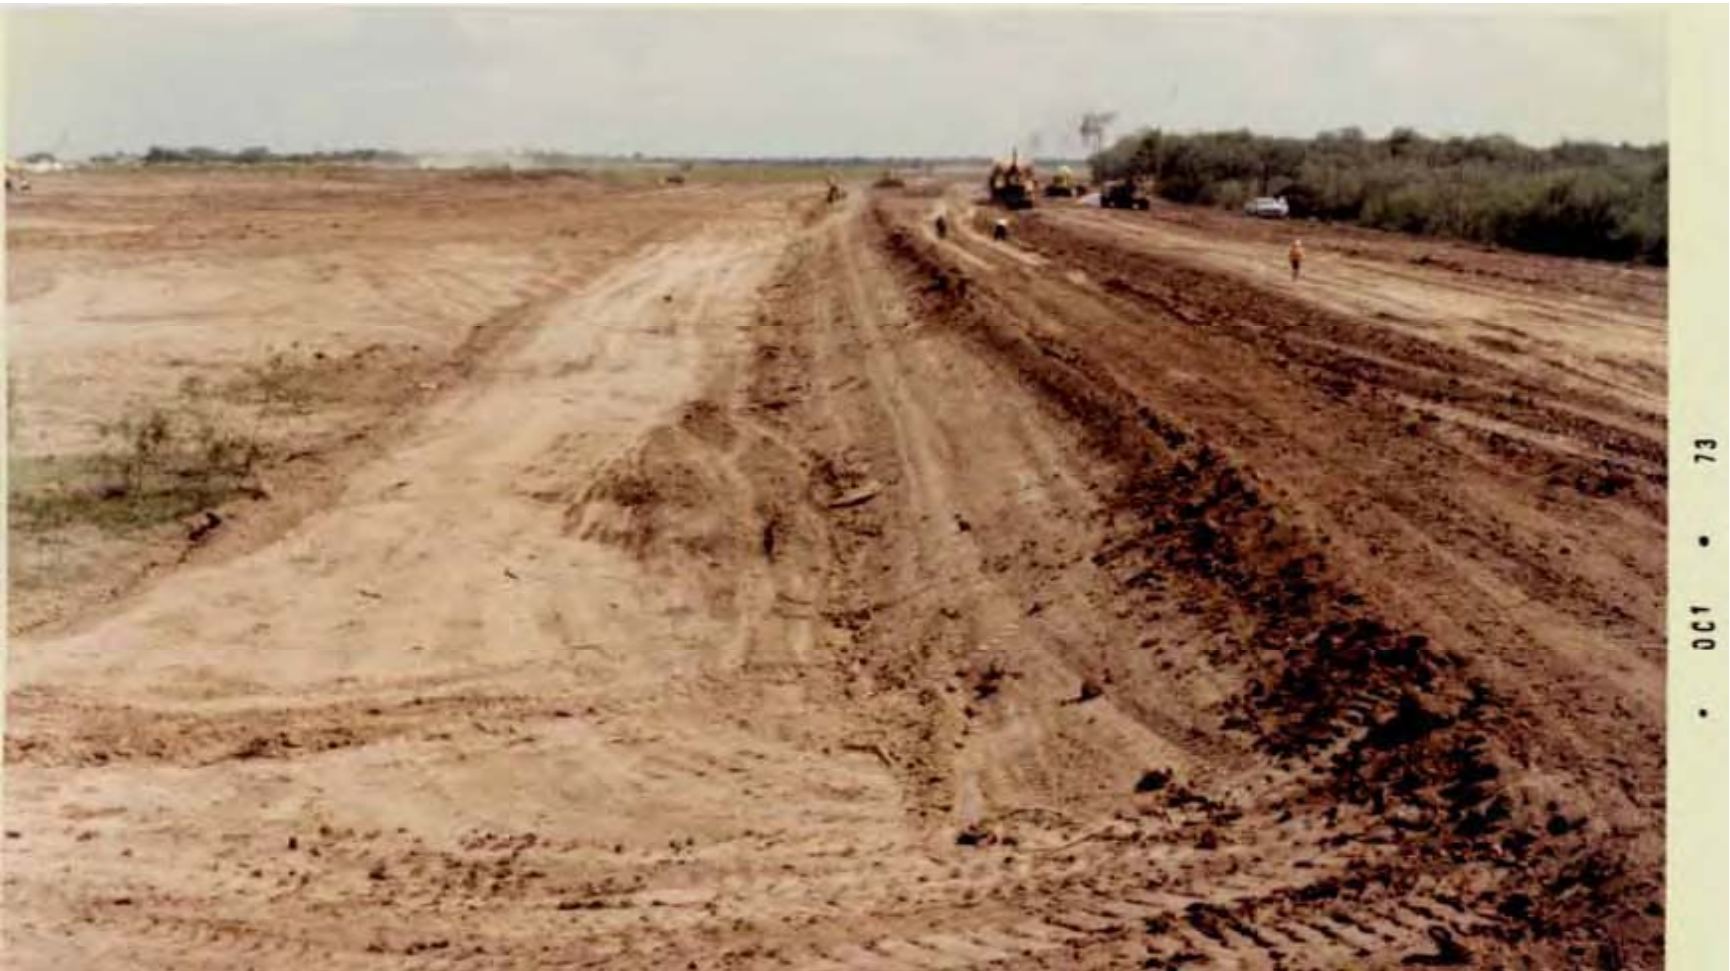
Figure 7. Retamal levee construction photo from October 1973 with view looking west

Soils to build the levee were derived from nearby borrow pits as shown by IBWC construction drawings no. 19381 through 19386 (Figure 5 and Figure 6). Old Rio Grande oxbows and natural levees along the right-of-way were a primary source for borrow material to build the levees. The reach of levee at the test pond site was built from soils obtained from Borrow Areas 2 and 3 (Figure 6), which is within the Longoria Banco. Construction drawings Nos. 19381 through 19386 identify the locations of the different borrow pits used to build the levee along its right-of-way, and identify soil types from shallow borings made in the pits. According to construction drawing no. 19382, the levee at the test pond reach was built mainly of CH soils (Unified Soils Classification System, USCS). A construction photograph is presented as Figure 7.

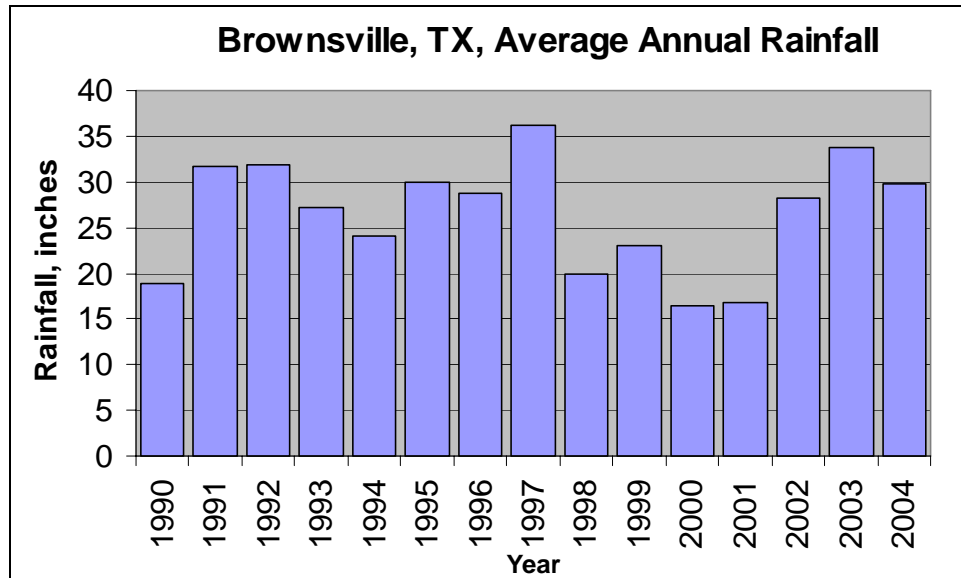
Figure 9. Annual rainfall (in inches) for Brownsville, TX, between 1990 and 2004. PDO cool cycle that began in 1996 (see Figure 8) contains 3 years with rainfall below 20 in., and 1 year below 25 in. (data from NOAA, NWS 2005)

Airborne geophysical surveys to support the condition assessment of IBWC levees in the LRGV were flown in late June and early July 2001, which corresponds to a dry year in Figure 9. Additionally, the survey was flown at the end of a 4-year period with lower than average rainfall. Low conductivity signatures

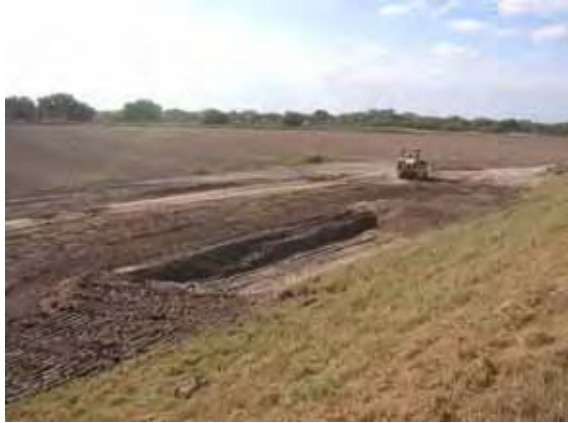
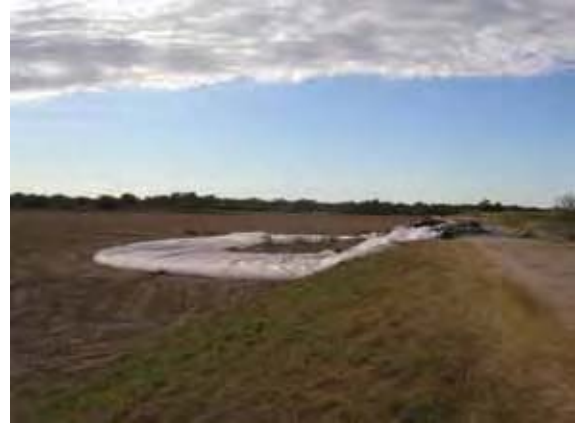
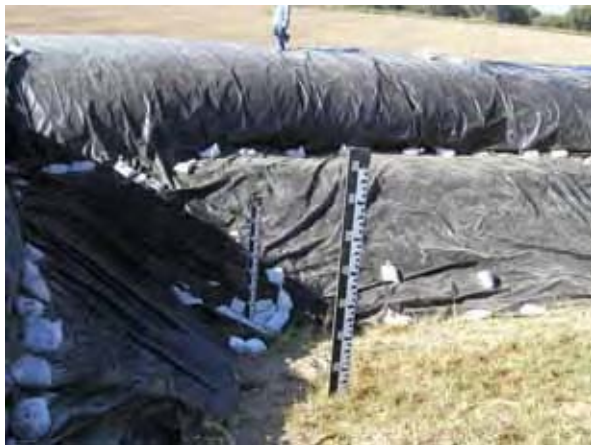
Figure 13. Photos of test pond showing: (A) preparation of foundation, (B) bladder before being filled with water, (C) filled bladder and the staff gages in empty pond, and (D) pond at full pool (11.5 ft, el 93.7 ft NGVD)

To ensure that the bladder did not leak on the riverside other than along the levee surface, a polyvinyl chloride liner was laid over the bladder and all liner joints were sealed with a heat-activated adhesive to prevent unwanted leakage (Figure 13, photo C). Upon completion of the test pond, only the earthen face of the levee was exposed to the floodwater. A staff gage was placed in the test pond to monitor water levels. Controlled raising and lowering of the water elevation was performed with pumps. IBWC provided the pumps (2-in. and 4-in.) and fuel. ERDC personnel maintained the water level in the pond during the test.

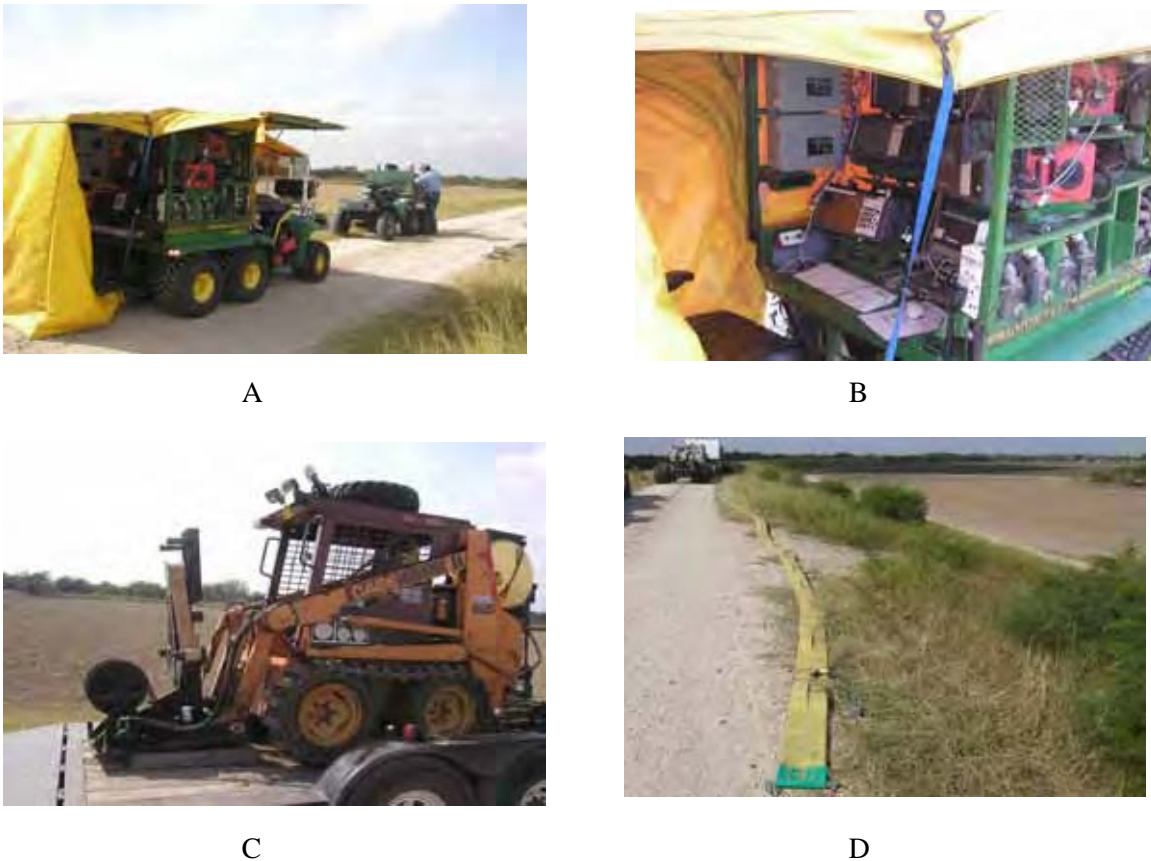
Figure 18. Seismic equipment used during investigations of IBWC levees: (A) seismic recording cart, (B) close-up view of seismographs in recording cart, and (C) seismic source for producing surface waves, (D) towed land streamer or geophones in fire-hose for rapid seismic surveying capabilities and fixed geophones (in blue, foreground) were evaluated

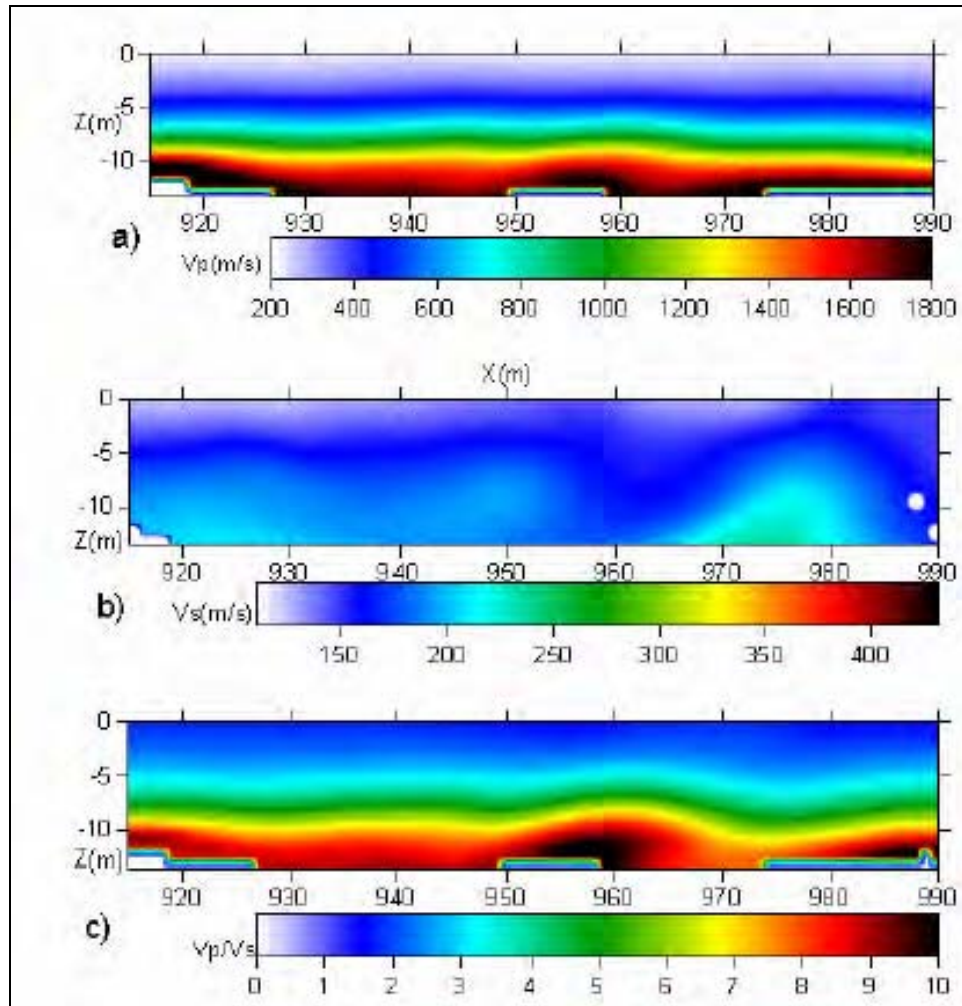
Figure 19. Refraction tomography solutions for the pond site in December 2003: (a) P-wave, (b) S-wave, and (c)  $V_p/V_s$  ratio (Ivanov et al. 2004). (Velocities are in meters/second)

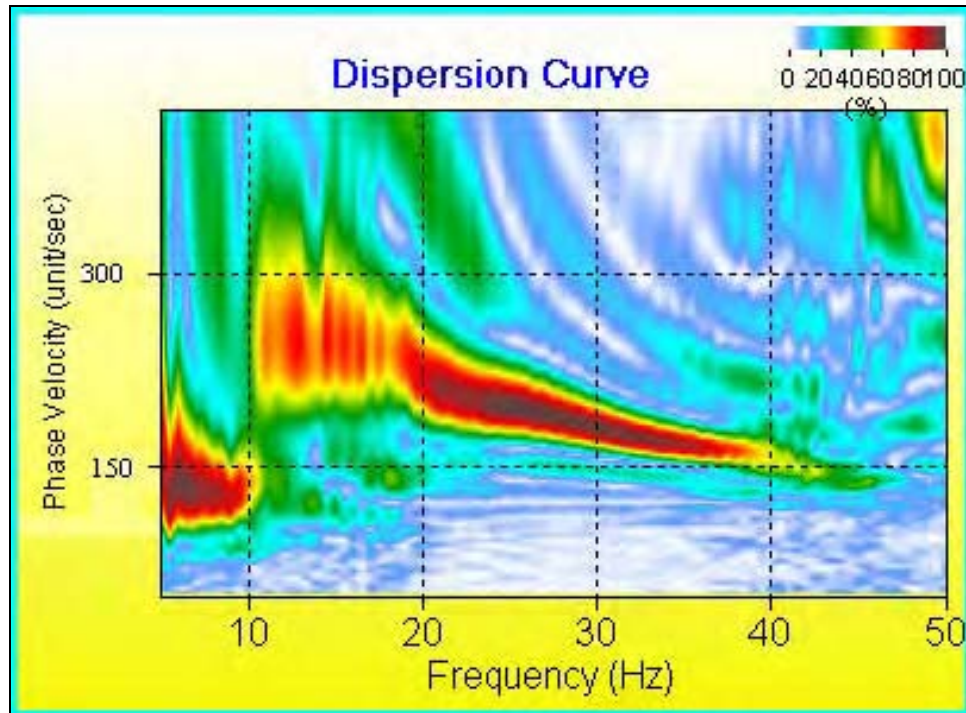
Figure 20. Rayleigh-wave dispersion curve analysis of phase-velocity versus frequency in units of ft/sec (Ivanov et al. 2004)

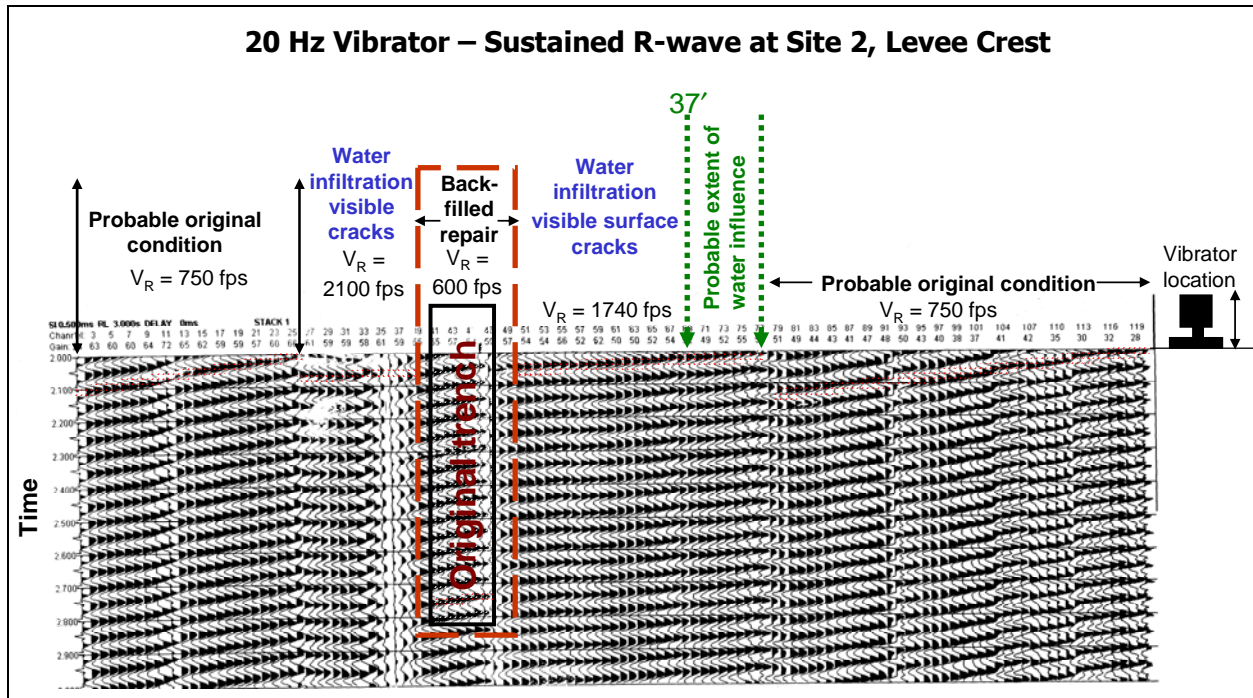
Figure 21. Phase velocities of levee at 20-Hz vibrator monofrequency, Rayleigh-wave velocity  $V_R$  is different for original levee, levee trench backfill, and area of levee core infiltrated by water from ponding test in October 2003. Seismic line contains 119 geophones at 3-ft spacing. Vibratory source at western or upstream end of levee and produces approximate 2000 ft-lb at 20 Hz

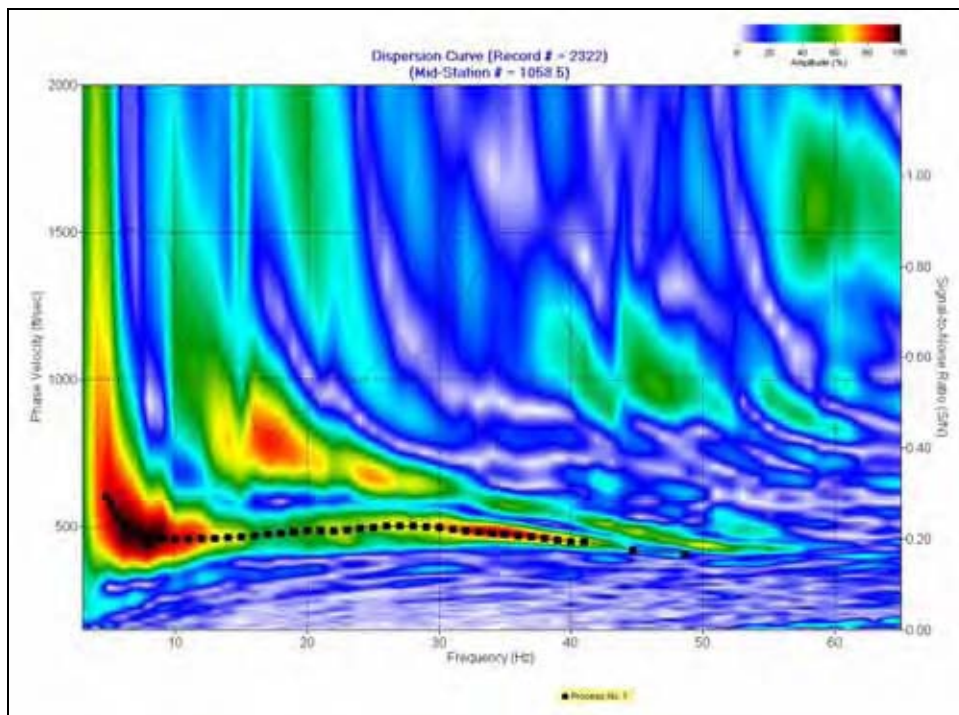
Figure 22. Rayleigh-wave dispersion curve analysis of phase-velocity versus frequency (in units, ft/sec) for November 2004 data collection at site 2 (Ivanov et al. 2005)

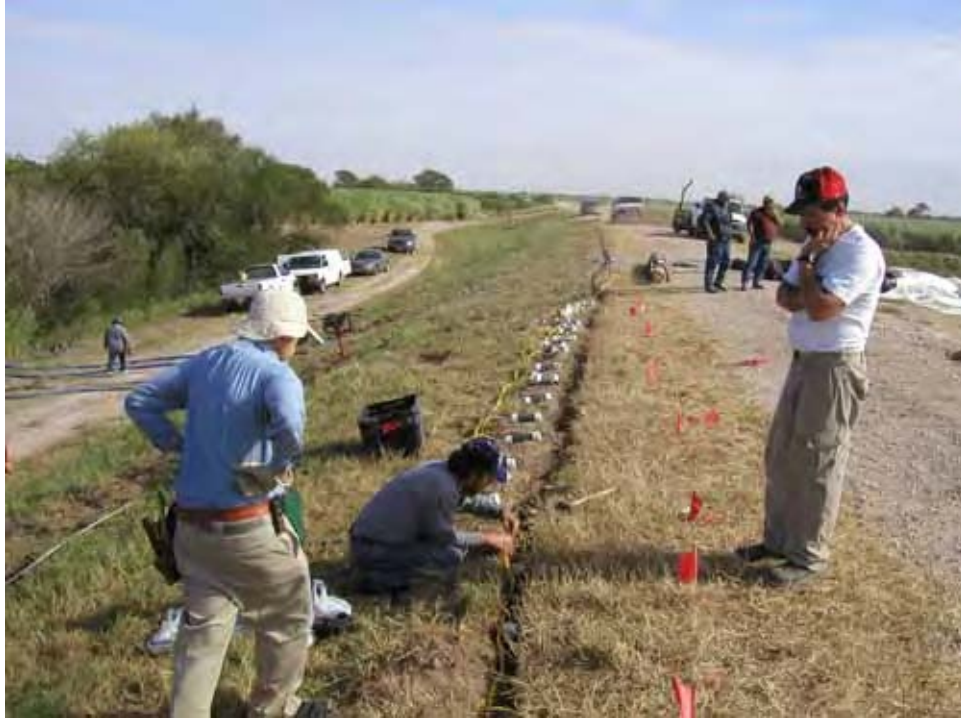
Figure 25. Installation of SP line (line A) along landside crest of levee. See Figure 15 for location of line A

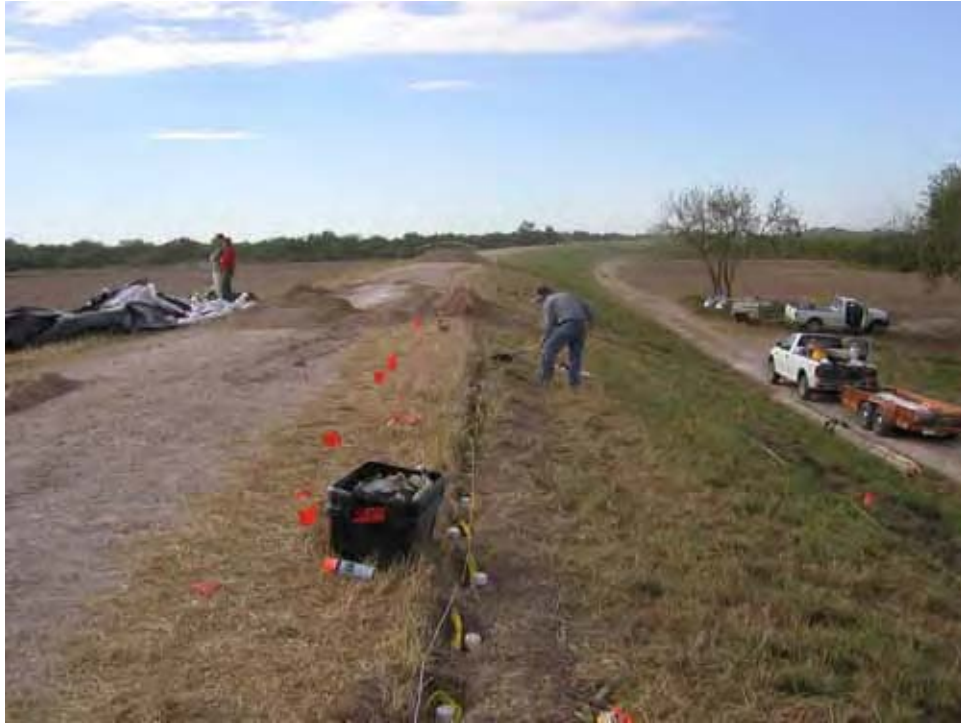
Figure 26. View of SP line (line A) looking upstream (west). Electrodes spacing is 2.5 ft, total length of line is 50 ft

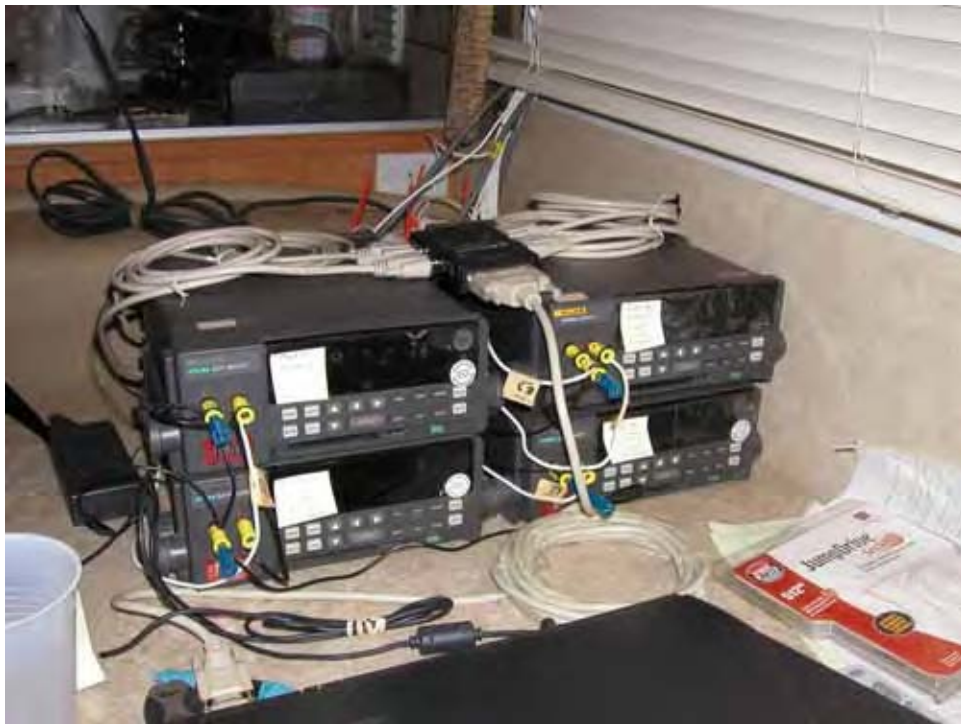
Figure 27. Data recorders used to measure voltages on each SP line of electrodes

Each electrode array was connected to an automated data acquisition system (Figure 27). Measurements were made every 2 min, starting about 36 hr prior to the test and throughout the duration of the test. Measurements were made between each electrode and a common ground electrode (E3), located 160 ft due east of electrode A20 on the levee crest (Appendix F, Figure 2). Each set of measurements was recorded to a separate data file and involved voltage measurements on a total of 84 electrodes, that is, 80 electrodes in lines A, B, C, and D, plus 1 common electrode (E3), and 3 auxiliary electrodes (E1, E2, and E4) (see Appendix F, Figure 2). Detailed information about the SP equipment, recording interval, data formats, and processing of the different data files is presented in Appendix F.

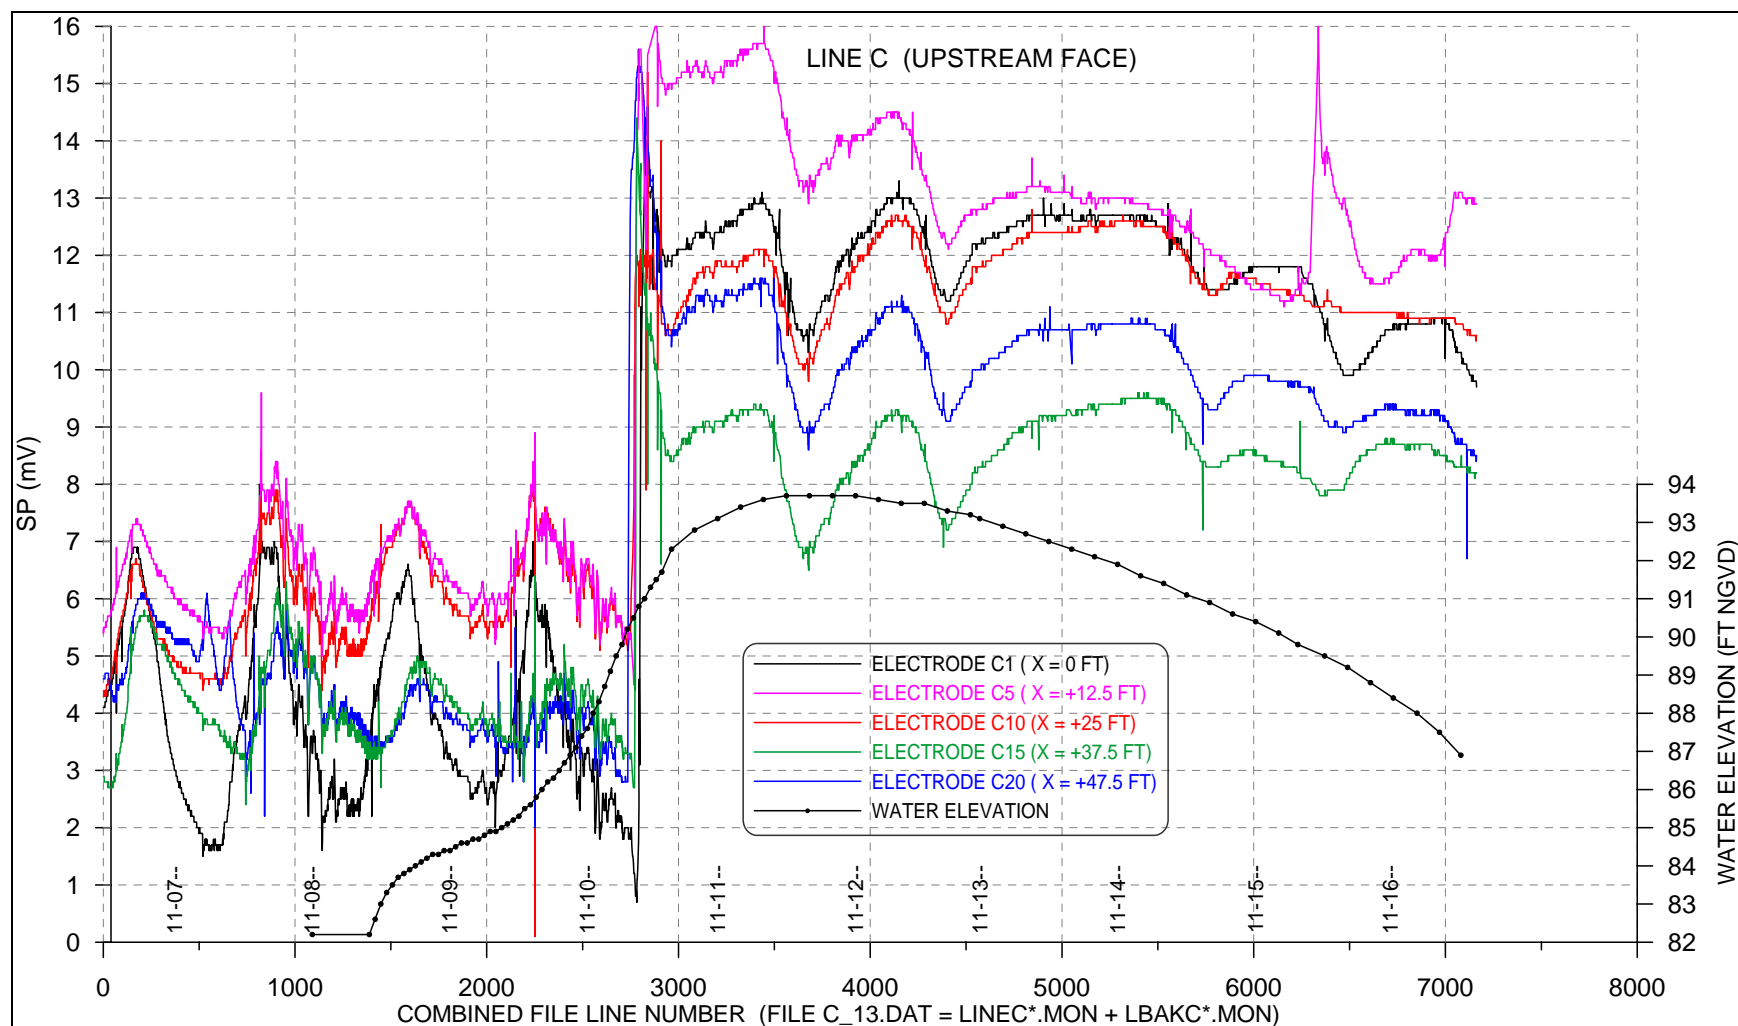
Figure 28. SP monitoring data for Line C (upstream face). Note that electrodes are submerged approximately midway during test, causing sharp increase in voltage

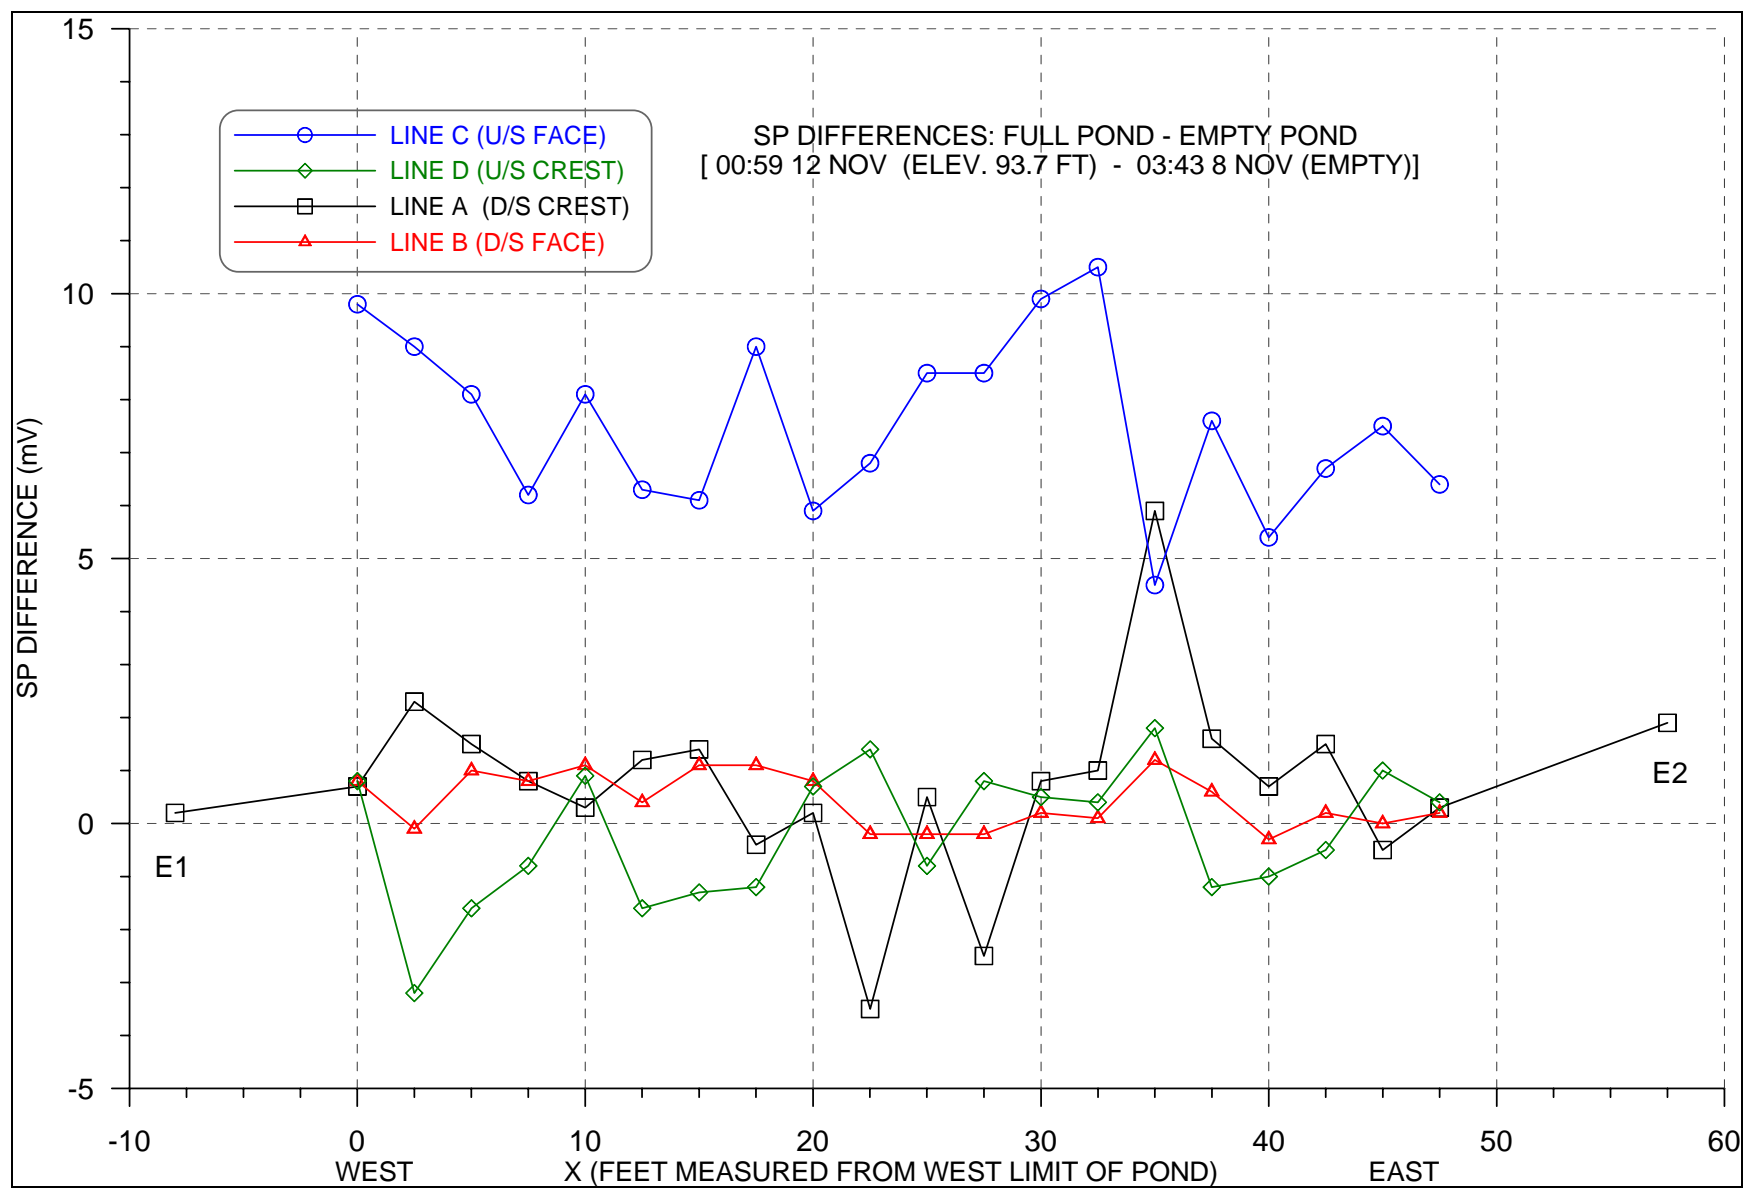
Figure 34. SP difference profile plots (full pond at el 93.7 ft – empty pond)

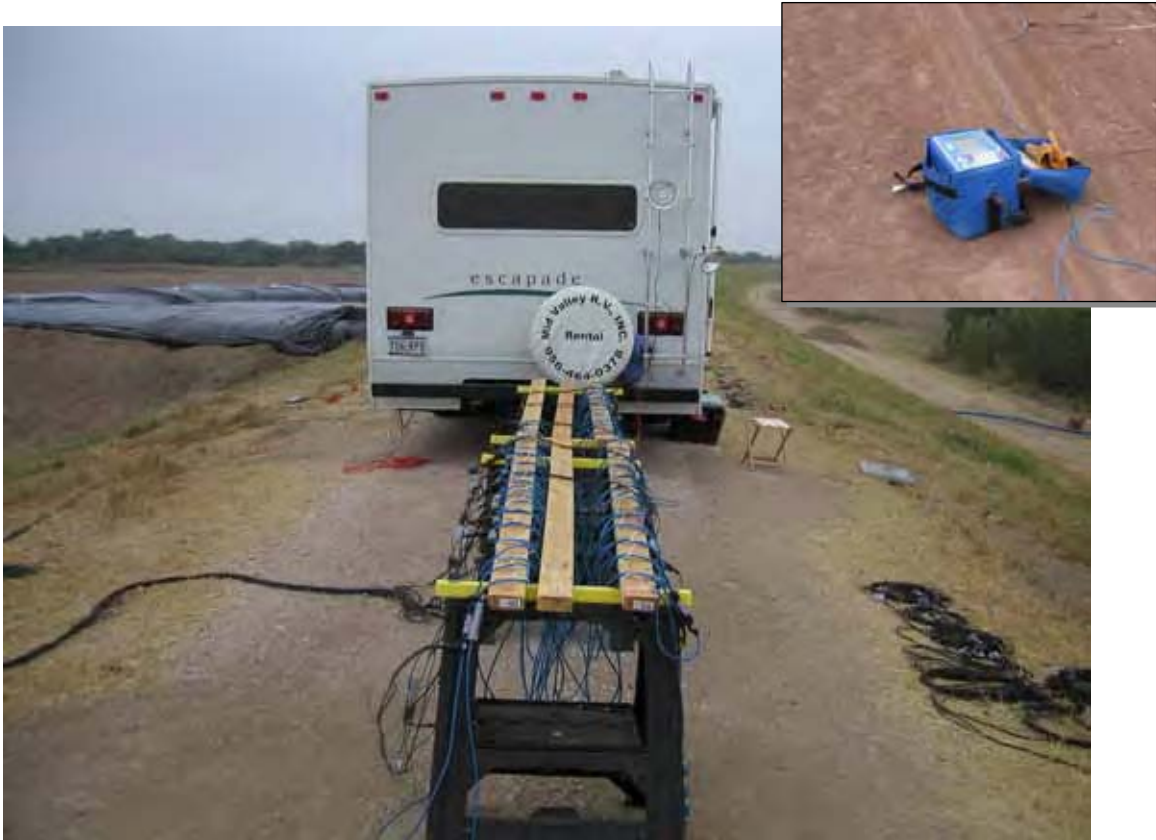
Figure 36. Resistivity measurement station behind RV during the flood test. (Electrodes in each resistivity line were connected to blue cable at numbered take-out locations. Numbered electrodes from each line were connected to a specific location on the blue cable. Blue cable plugs into the SARIS automated electrical resistivity meter, which records voltage measurements between the potential electrodes to data files, and automatically advances the measurement location along the electrode array by a specified distance. Resistivity profiles of the subsurface along each line are produced by inversion of these data by computer programs)

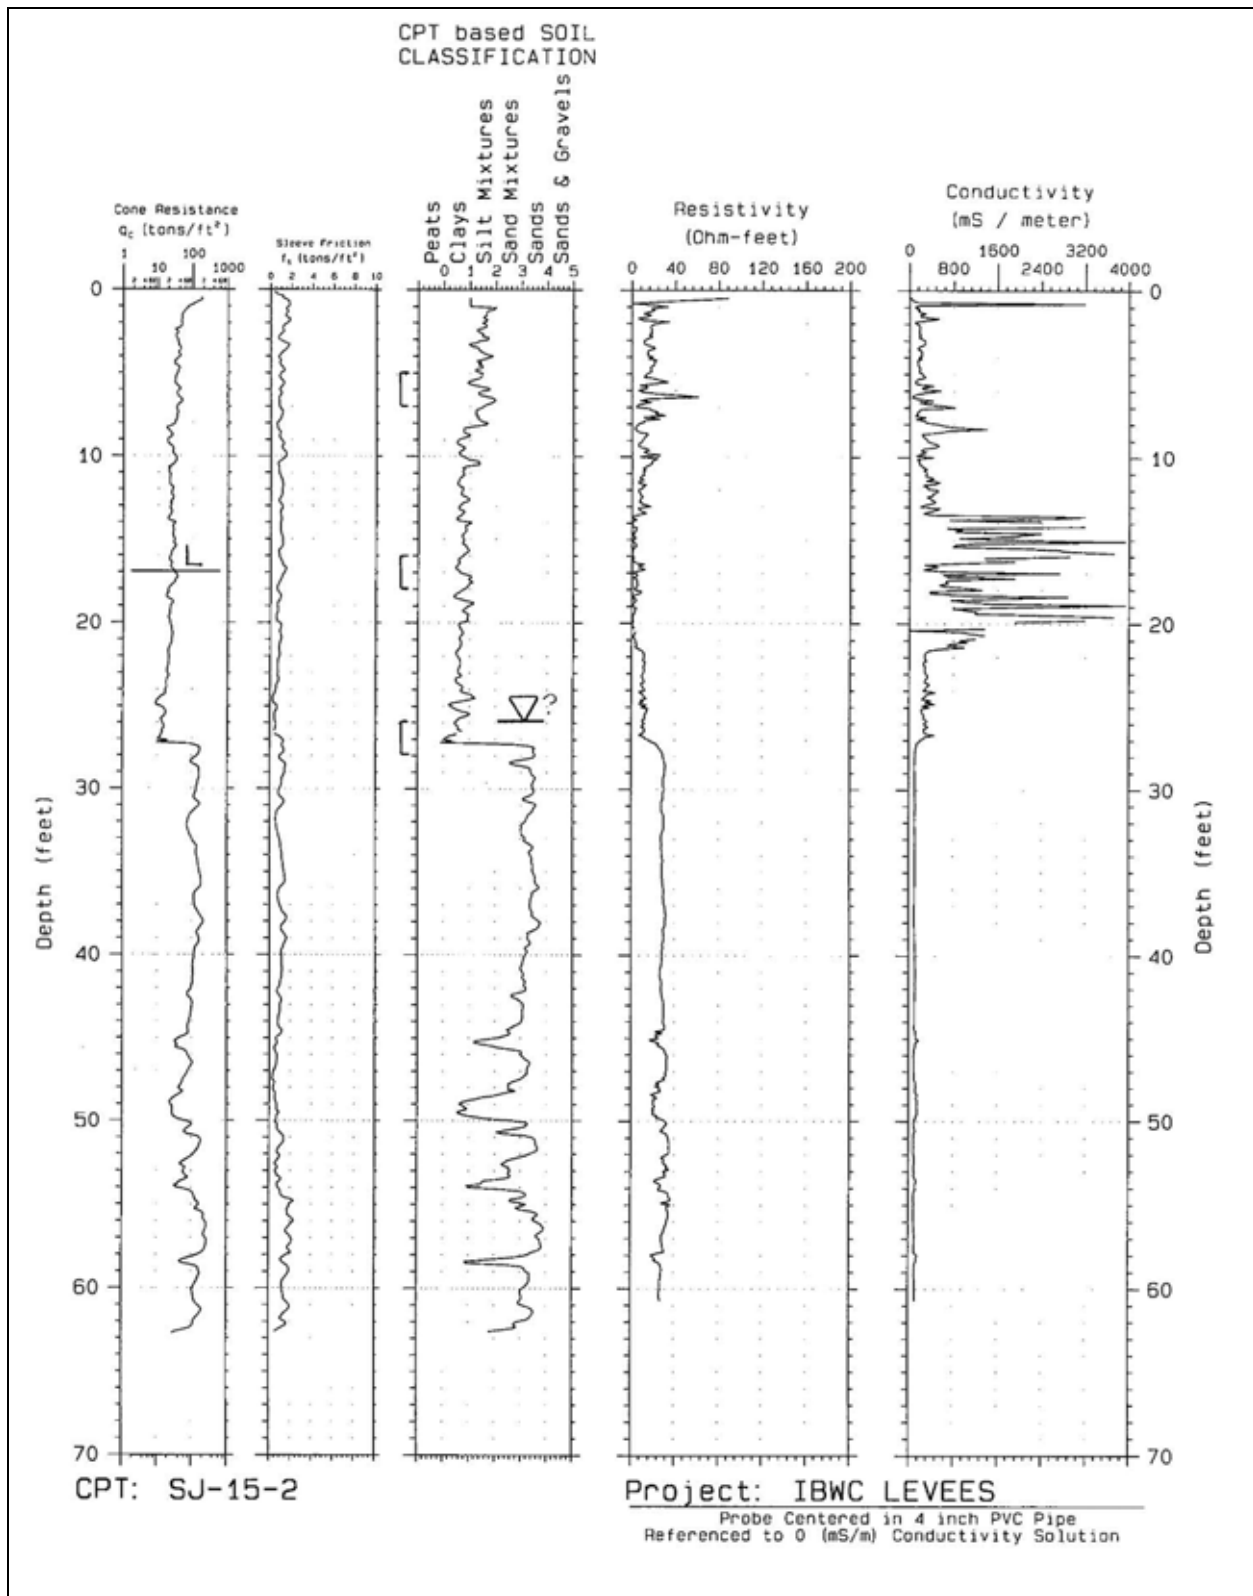
Figure 40. Cone penetrometer log SJ-15-2 pushed 10 December 2002 at levee center line near pond

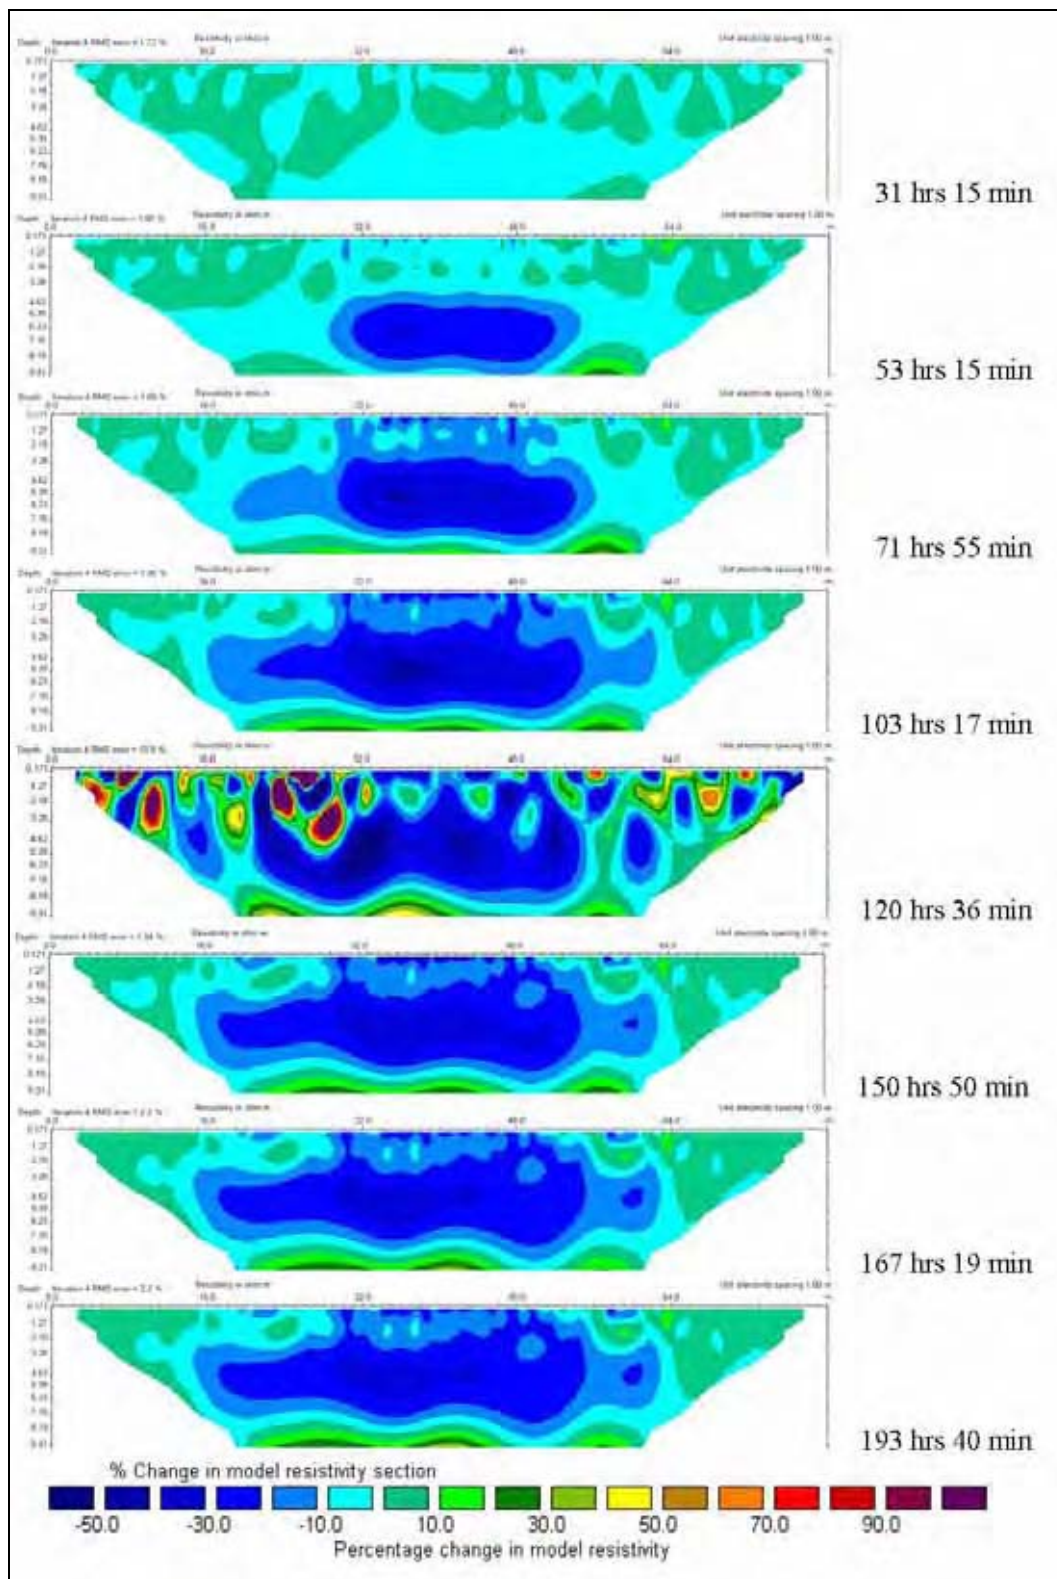
Figure 41. Percent change in model resistivity for levee crest

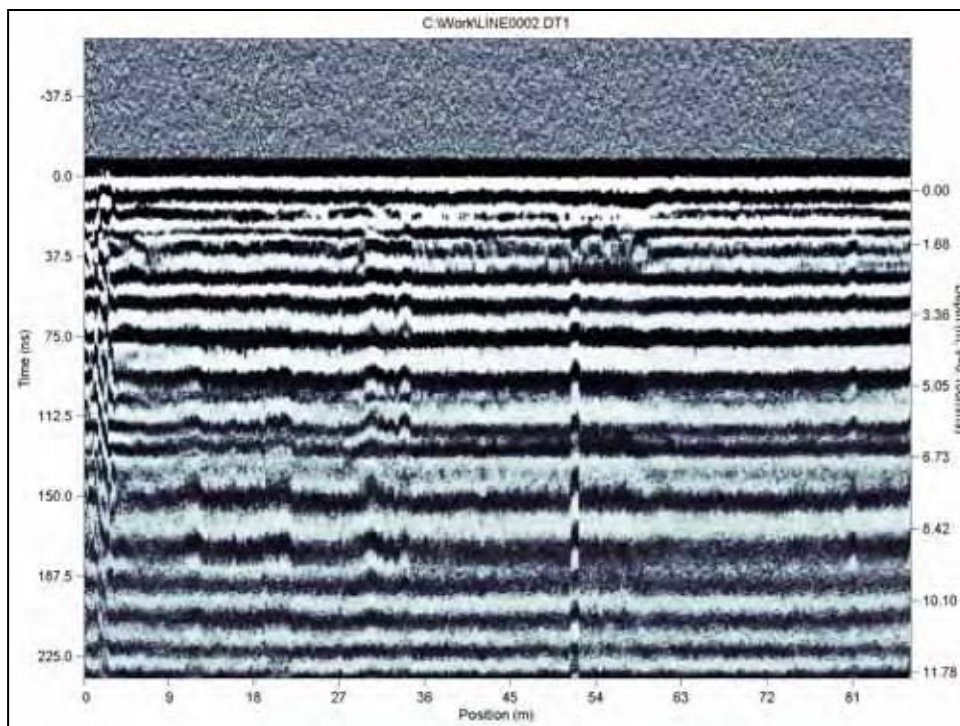
Figure 48. GPR record from river side crest with 100-MHz antenna, view looking south with section extending from east to west

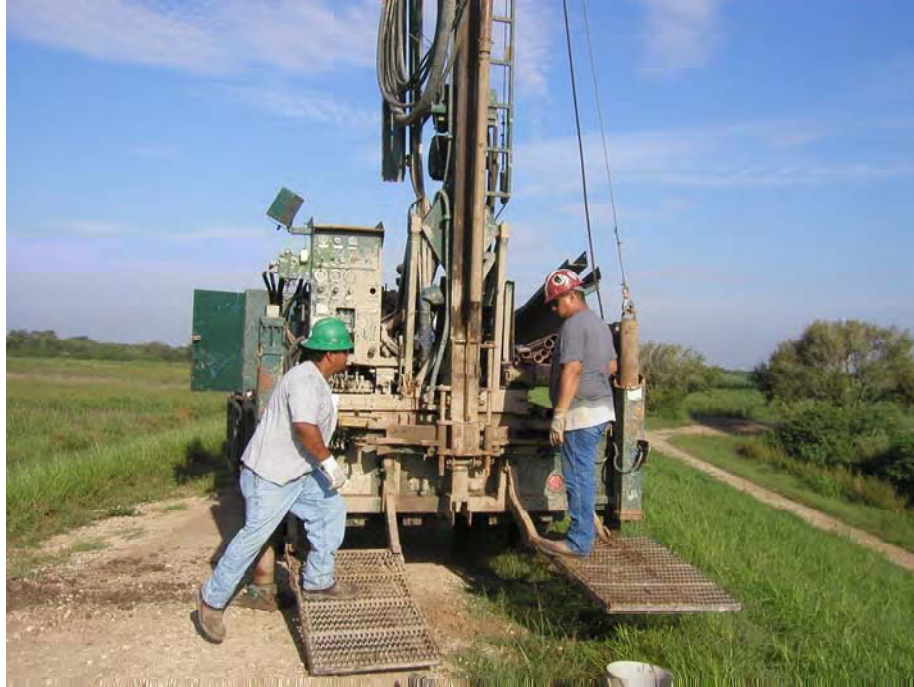
Figure 1. Soil sampling of levee at location SJ-TX-02. Boring SJ-TX-01 is located 10 ft to left on south levee crest.
